Enhanced Preliminary Assessment Report:

Rocky Point Army Housing Units Rocky Point, New York

November 1989

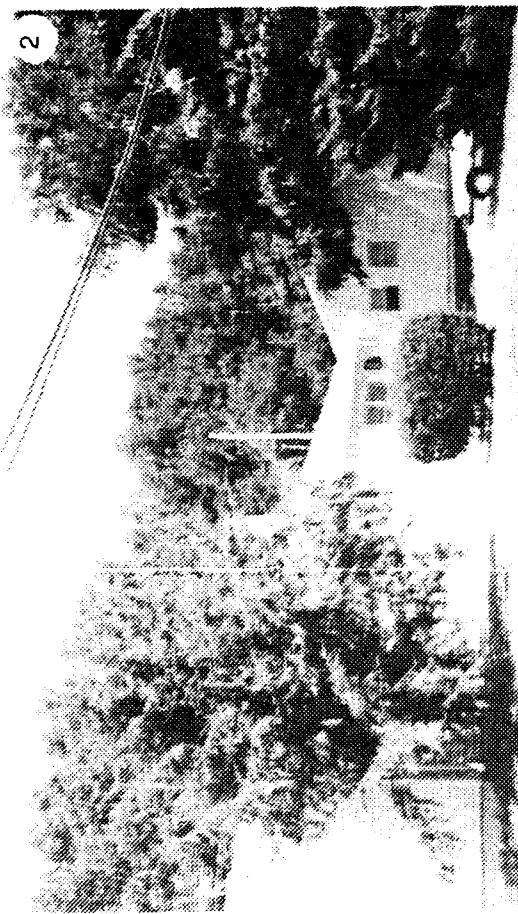
1. Typical unit at Rocky Point housing; note concrete slab foundation.
2. Typical unit at Rocky Point housing; property east and west of housing site is primarily undeveloped county property.
